AGENDA ITEM: 13C

DATE: 04/9/2026
TO: Board of Directors
FROM: Daniel Haggard
SUBJECT: Review and Accept the Pavement Condition Index (PCI) and 5-year Pavement Management Plan (PMP) Report and Provide Direction to Staff on Next Steps

Bear Valley , CA

Pavement Management Report

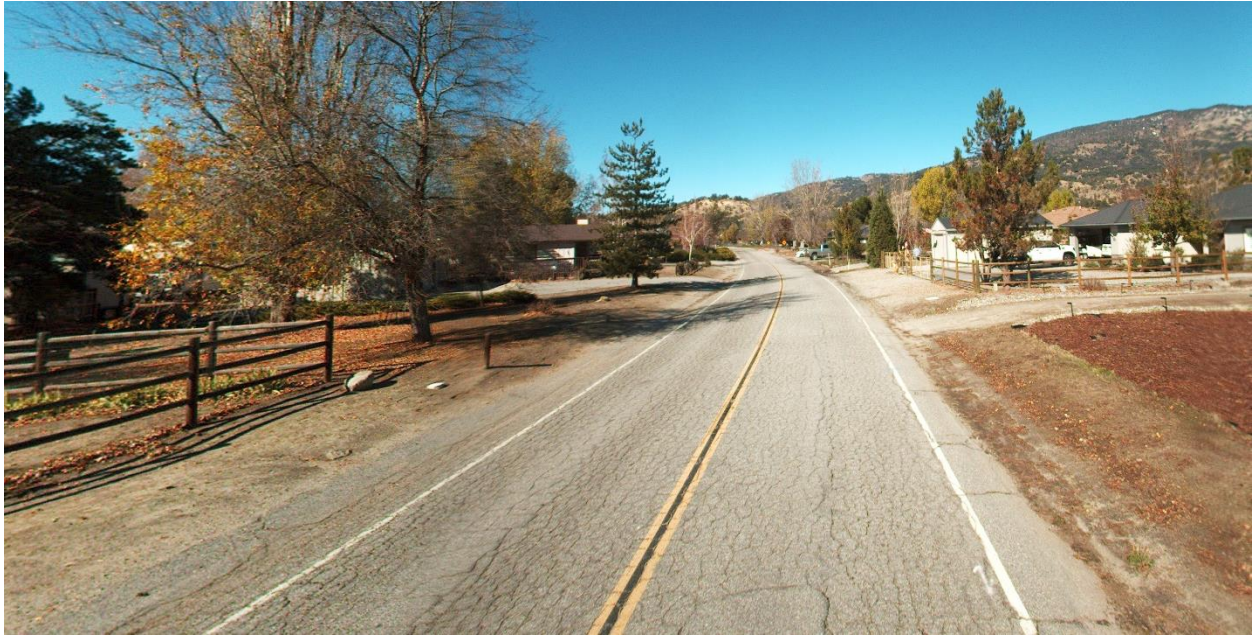
Very Poor (PCI = 0 to 25) – Complete Reconstruction

Pinedale Drive (PCI = 7) – Rated as Very Poor, this street displays a large quantity of alligator cracking severe enough to suggest that the pavement structure is inadequate for current traffic loads. The rehabilitation of roads in this condition through a mill and overlay is generally ineffective, as the failures usually extend to the bottom of the pavement layer. Streets in this condition require rehabilitation that involves removal and replacement of the asphalt layer, base stabilization, or complete reconstruction based on design requirements.

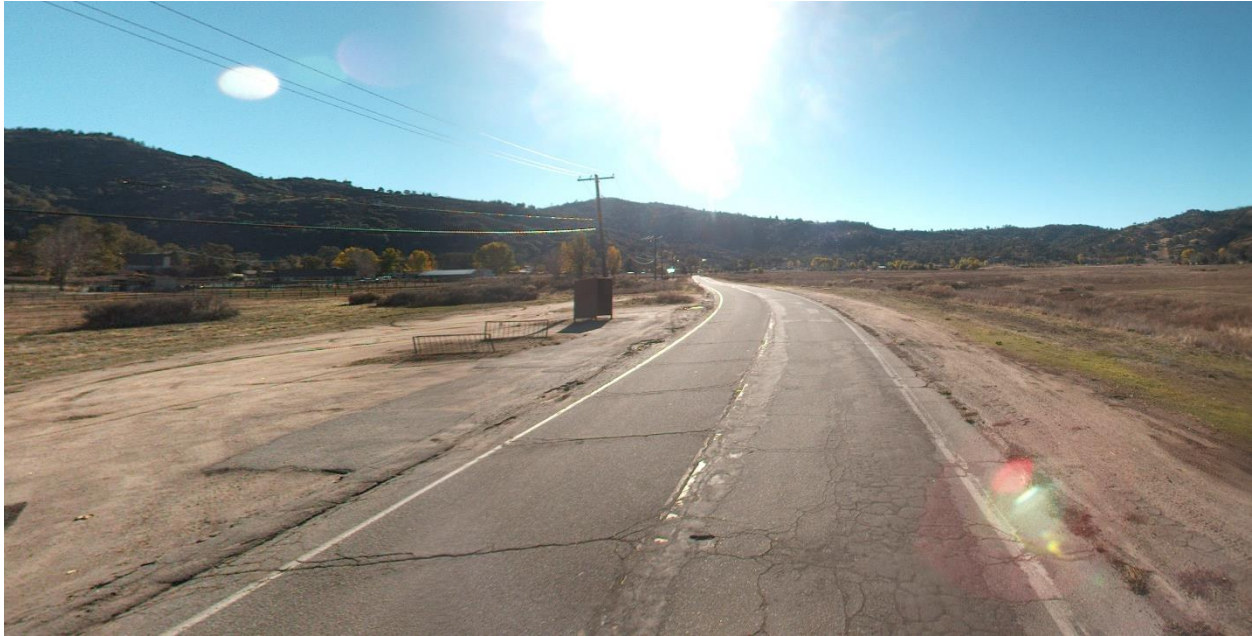
Poor (PCI = 25 to 40) – Last Opportunity for Surface and Base Rehabilitation

Lower Valley Road (PCI = 30) – Rated as Poor, this segment still has some remaining life before it becomes a critical reconstruction need. As evident in the imagery, a fair amount of the segment contains alligator cracking. There are also deep longitudinal and transverse cracks, particularly along the edges of the pavement. If left untreated, a partial to full reconstruction would be required within a short period of time.

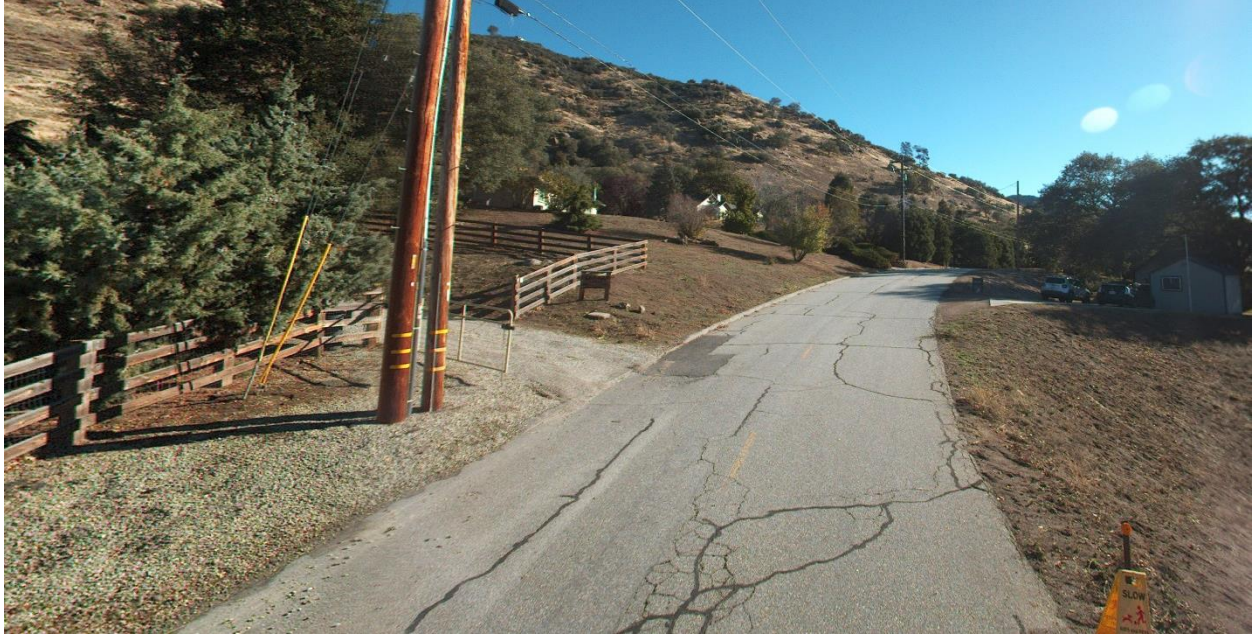
Marginal (PCI = 40 to 50) – Thick Overlay

Cumberland Road (PCI = 46) – This street displays transverse and longitudinal cracking across the middle and edges of the pavement. Some, but not all cracks have been sealed. There are sections of alligator cracking dispersed along the segment as well.

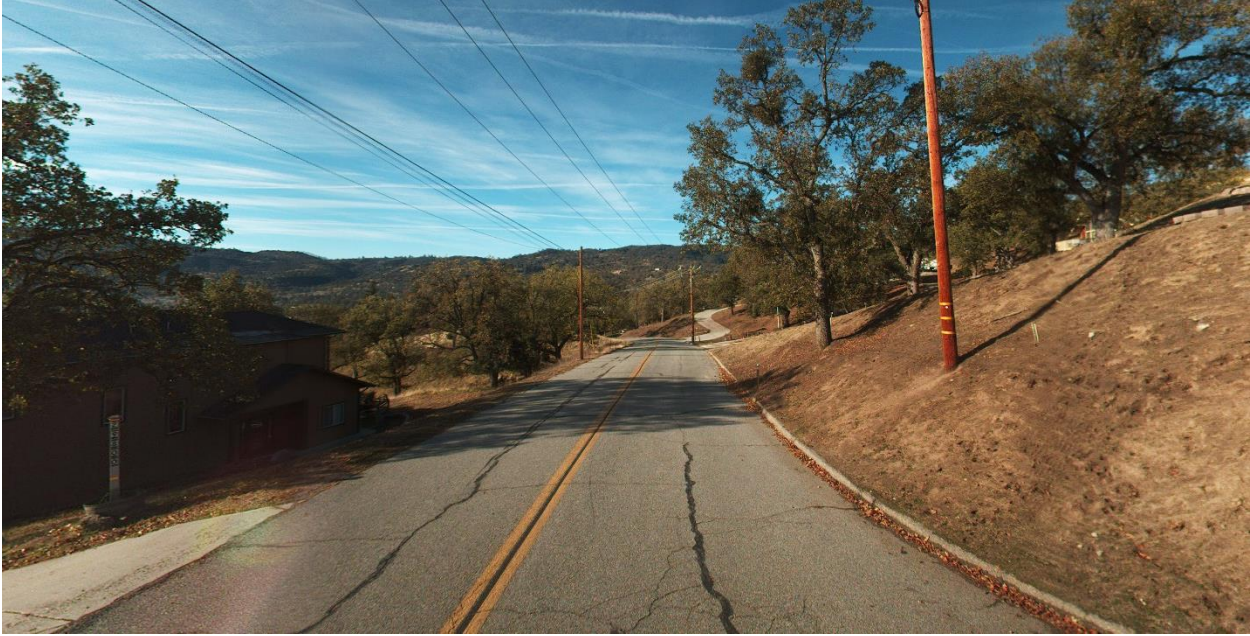
Fair (PCI = 50 to 60) – Moderate Overlay

Greenwater Drive (PCI = 56) – Fair streets have similar characteristics to Marginal streets in that the distresses present tend to be localized and moderate in severity; however, the distresses will predominately be non-load related (i.e., caused by environmental or other factors). This street displays block cracking towards the middle of the pavement. There are moderate amounts of longitudinal and transverse cracking, with some cracks being deep but localized.

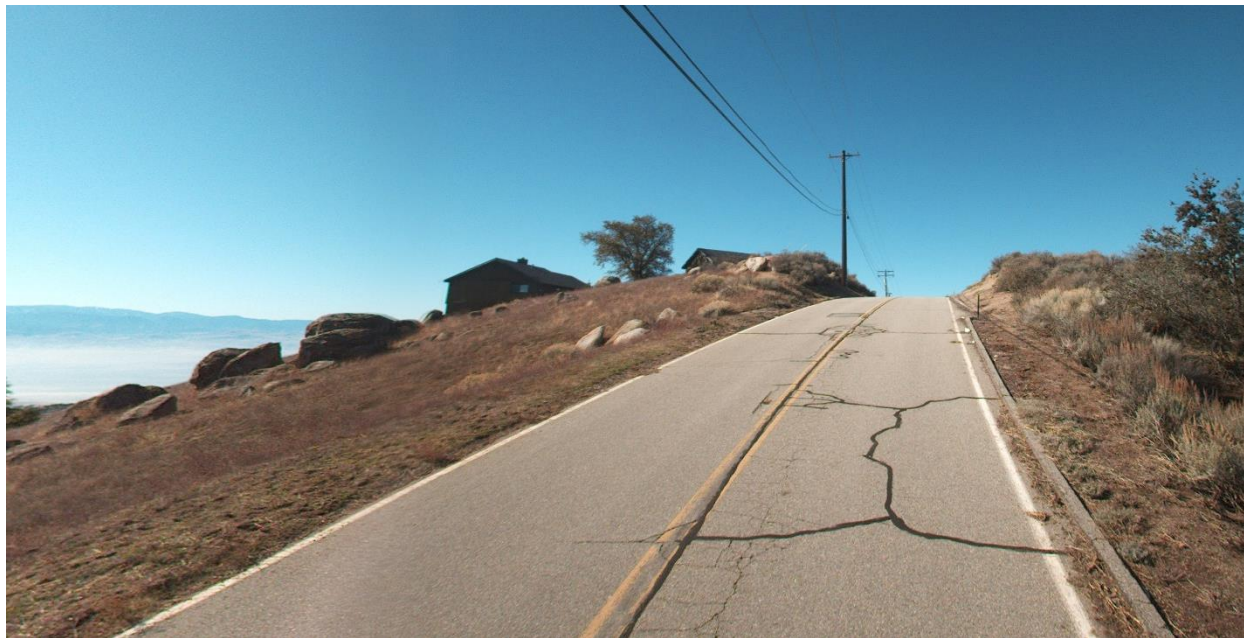
Good (PCI = 60 to 70) – Surface Treatments

Skyline Drive (PCI = 65) – Rated as Good, the primary cause of deterioration for this street is the longitudinal and transverse cracking. Some, but not all cracks have been previously sealed. The pavement surface could be restored with spot patching to remedy the more heavily distressed areas.

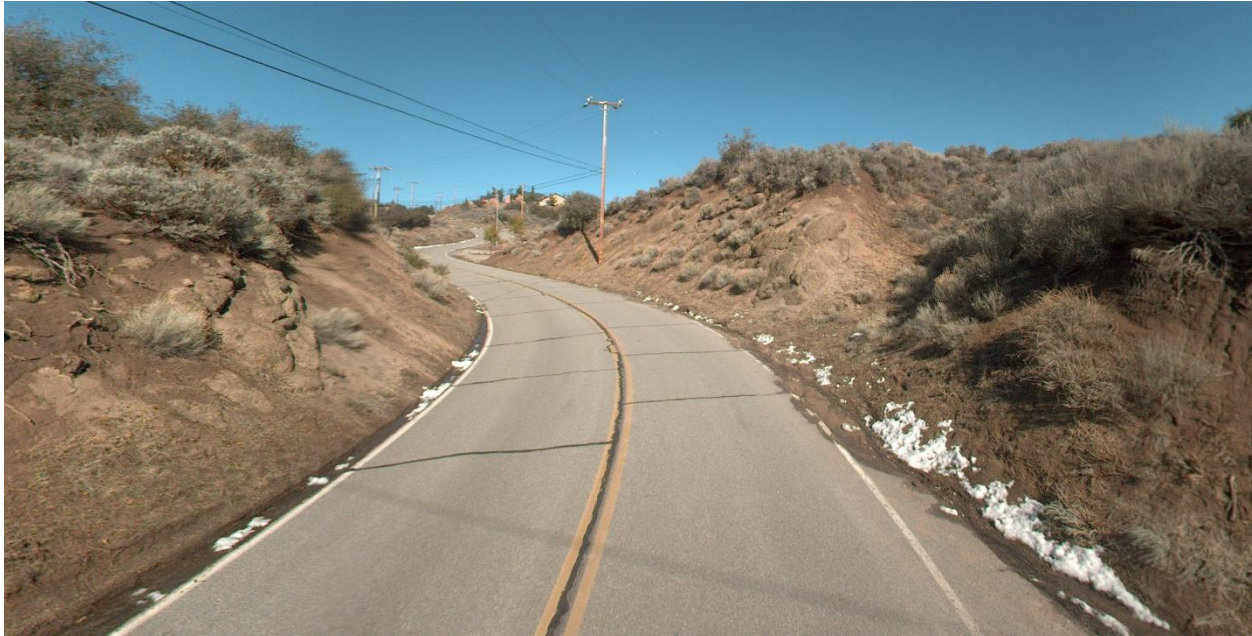
Very Good (PCI = 70 to 85) – Surface Treatments and Localized Rehabilitation

Jacaranada Drive (PCI = 79) – Rated as Very Good, this street displays minor amounts of transverse cracking. It is an example of a candidate for preventive maintenance to extend the life of the roadway.

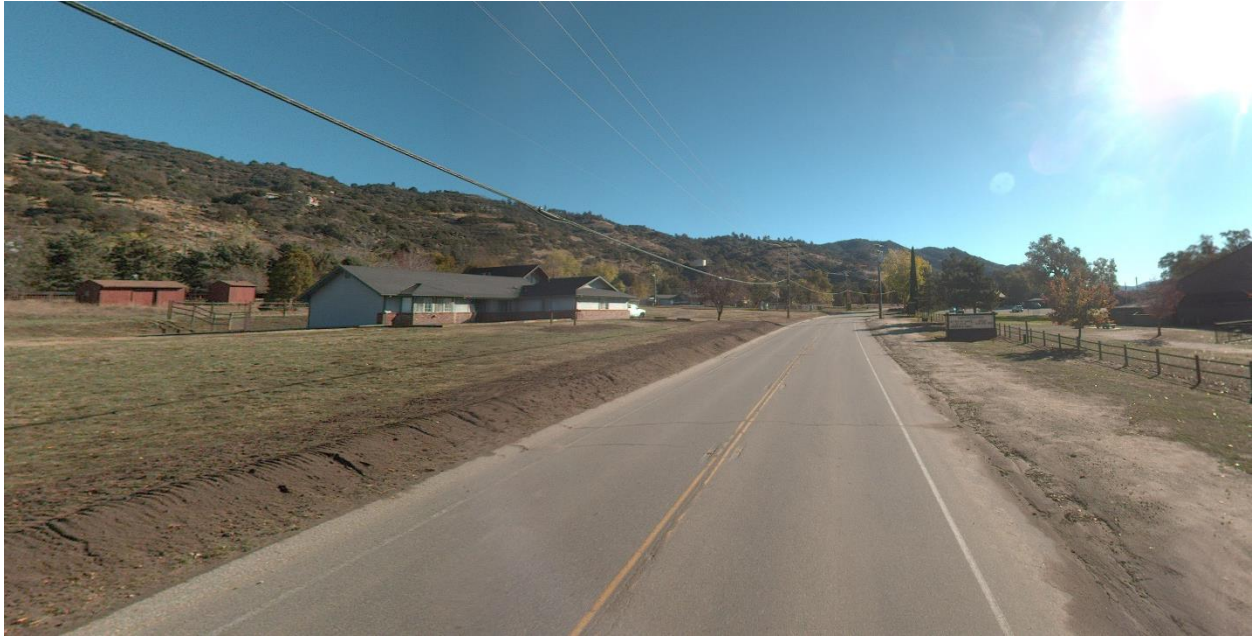
Excellent (PCI = 85 to 100)

Bear Valley Road (PCI = 90) – Rated as Excellent, this pavement displays little to no surface distresses. The ride is smooth, and the surface and the base are intact. Excellent roads should be periodically assessed for crack development that would trigger routine maintenance activities such as fog seals and rejuvenators.

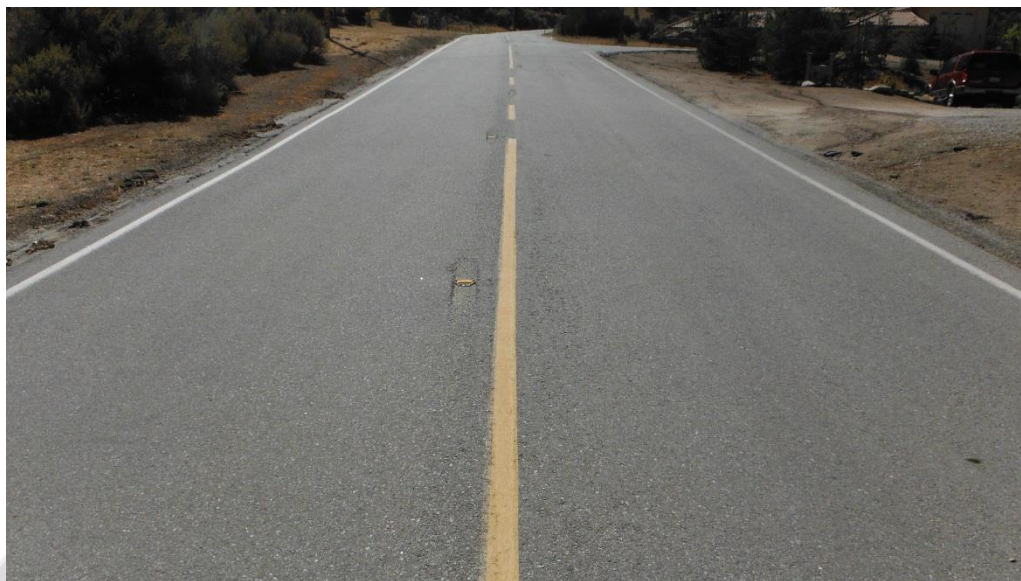
EXCELLENT

Skyline Drive, Section 02, PCI = 95

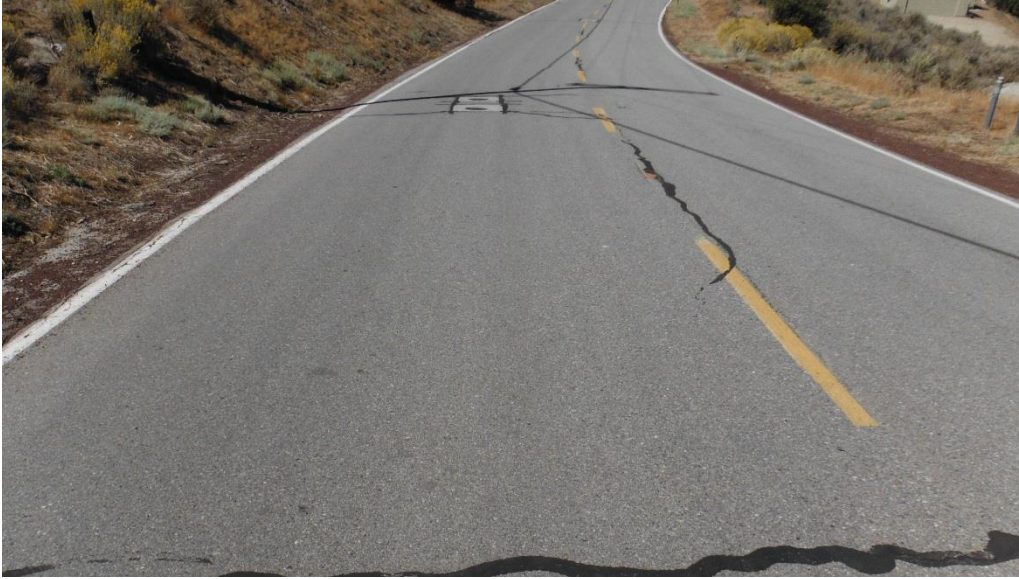
VERY GOOD

Jacaranda Drive, Section 08, PCI = 83

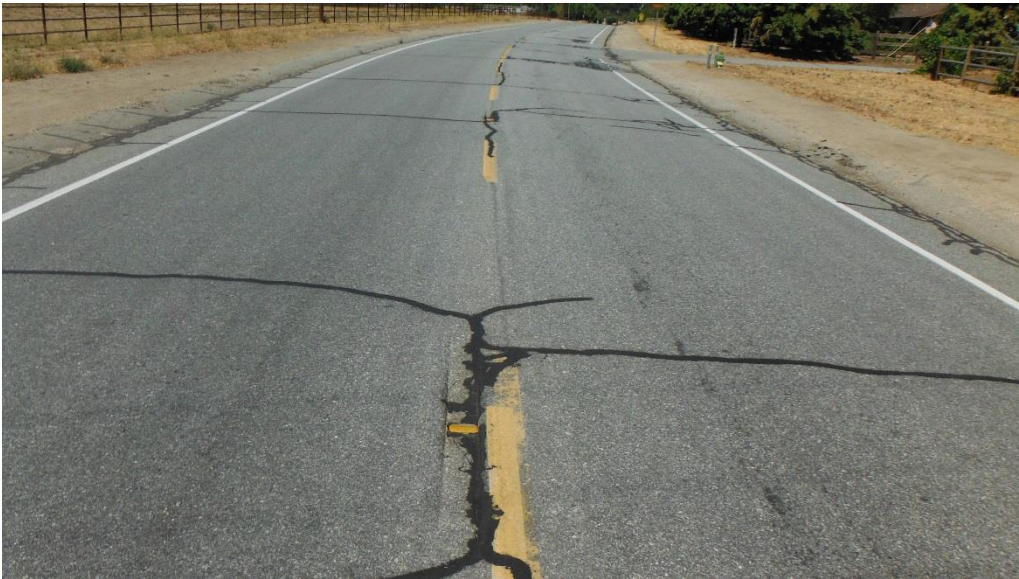
GOOD

San Juan Drive, Section 05, PCI = 72

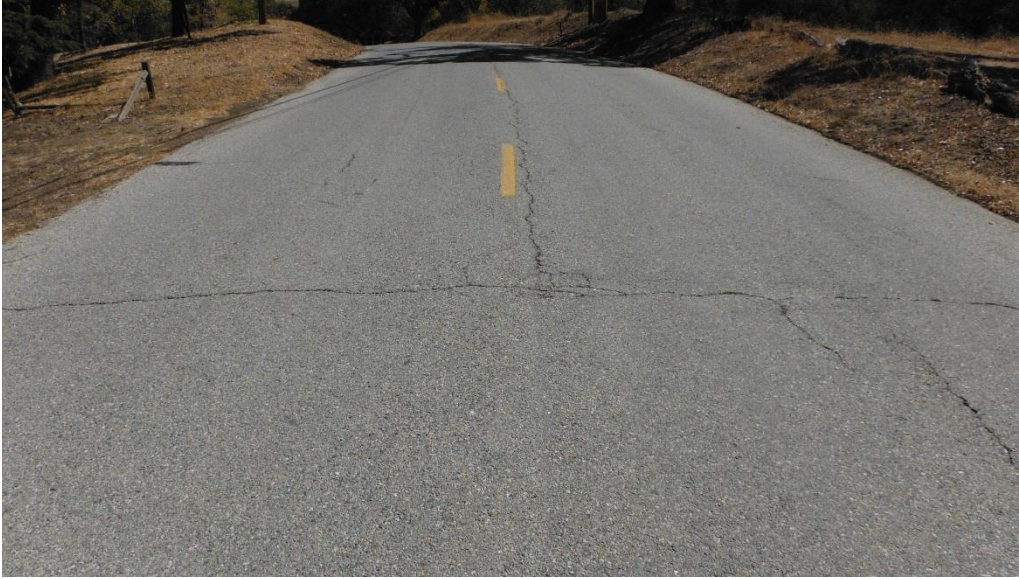
FAIR

Pinedale Drive, Section 04, PCI = 63

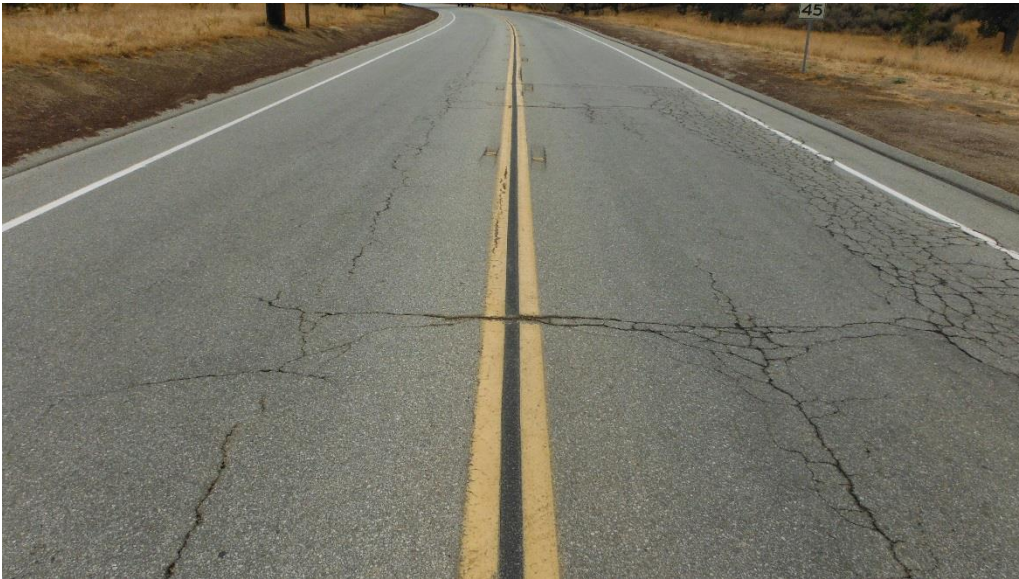
POOR

Bear Valley Road, Section 29, PCI = 40

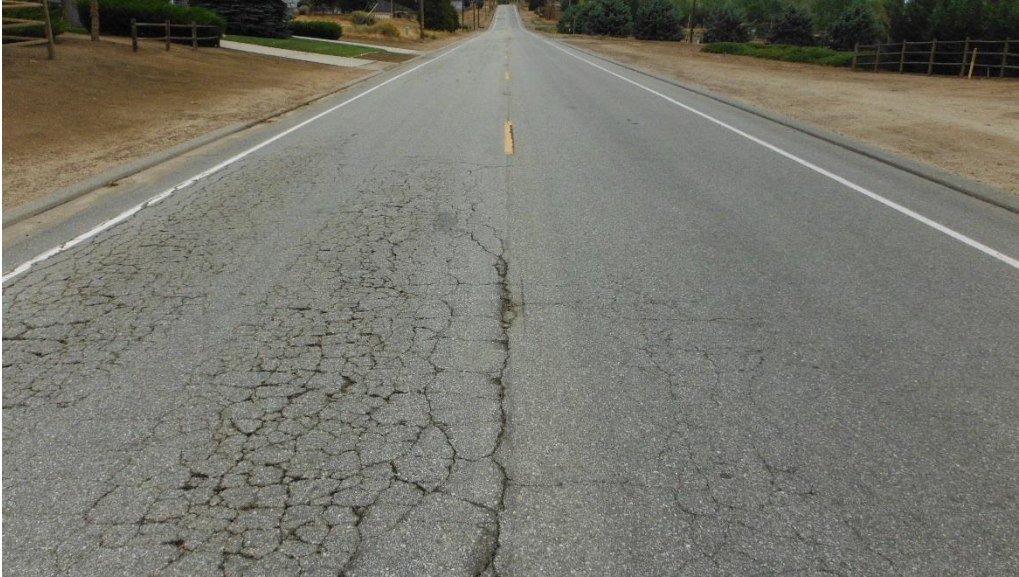
VERY POOR

Bear Valley Road, Section 21, PCI = 31

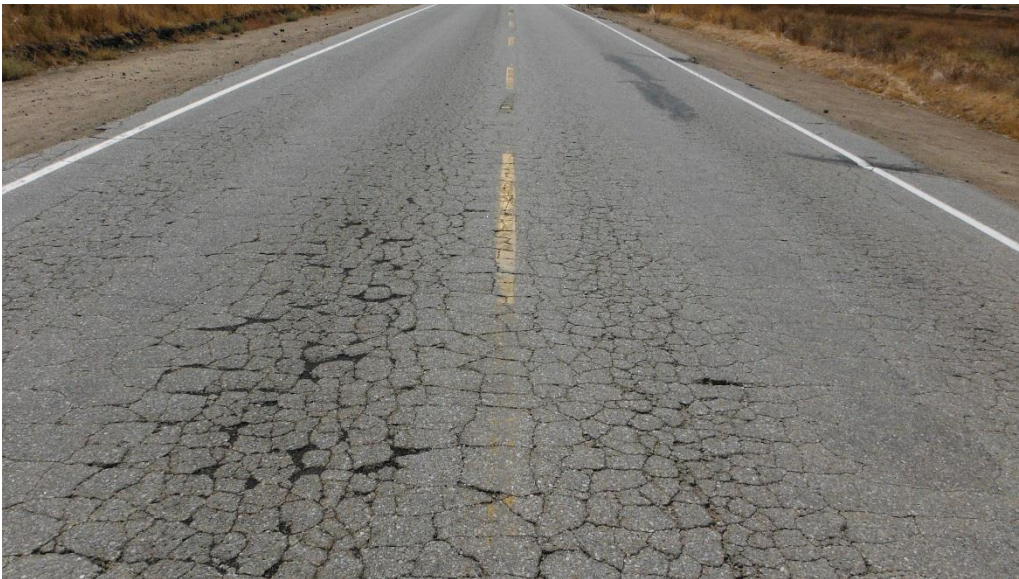
FAILED

Lower Valley Road, Section 04, PCI = 12
