AGENDA ITEM: 13C

DATE: 04/9/2026
TO: Board of Directors
FROM: Daniel Haggard
SUBJECT: Review and Accept the Pavement Condition Index (PCI) and 5-year Pavement Management Plan (PMP) Report and Provide Direction to Staff on Next Steps

Bear Valley , CA

Pavement Management Report

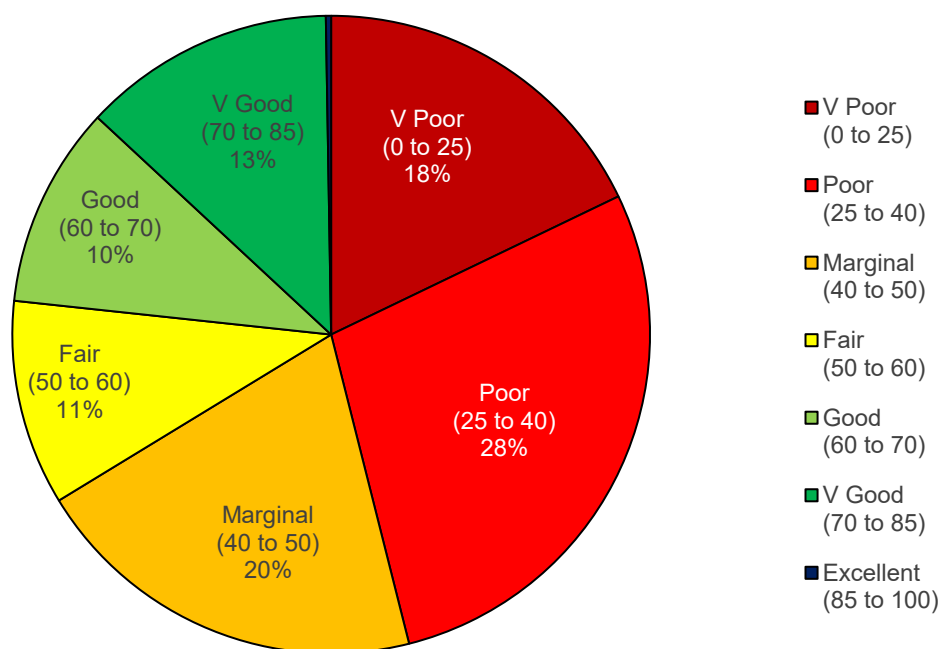
Figure 2 - Distribution of the Community's Pavement System on a Condition Scale

The Community’s roadways were generally found to be in Marginal condition with an **average PCI of 44**. **Figure 2** provides a visual breakdown of the distribution of pavement area across different PCI categories at the time of analysis. Approximately 13% of the Community’s roadways were found to be in Excellent or Very Good condition. If structurally sound, these pavements are often suitable candidates for cost-effective preventive maintenance treatments. On the other hand, pavements with a PCI below 40 (i.e., pavements in Poor or Very Poor condition) comprise the Community’s “backlog” of M&R. The Community’s **backlog was found to be 46%**. These pavements typically require full or partial reconstruction. Pavements falling within the middle categories, such as Fair or Marginal condition, often benefit from mill and overlay projects. It's important to note that these are general recommendations, and the specific M&R strategy may vary based on factors such as distress types, soil conditions, structural adequacy, and other project-specific details.

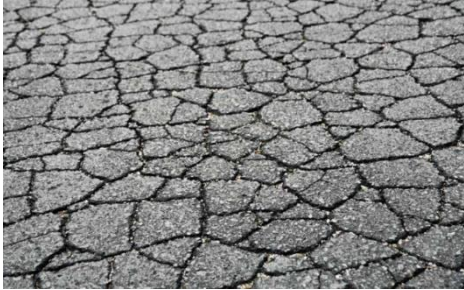
Distress Type	Pavement Type	Description	Example
Alligator Cracking	Asphalt	<ul style="list-style-type: none"> • Quantified by severity and square footage • Caused by the repeated bending from vehicle loads • Propagate from the bottom, meaning that structural failure has occurred • An LAD with significant impact on the condition score, even at low extents

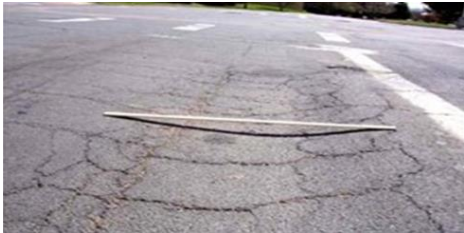
Rutting	Asphalt	<ul style="list-style-type: none"> • Caused by the permanent deformation of the pavement and/or subgrade layers • Even in Low densities can have a large impact on the final condition score due to their implication of possible structural failure

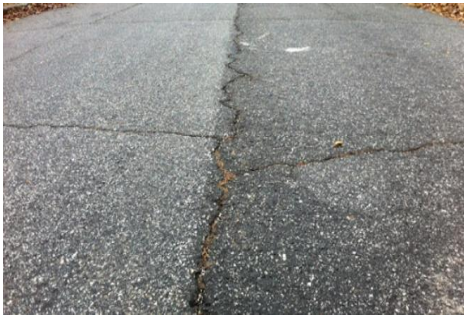
Longitudinal & Transverse Cracking	Asphalt	<ul style="list-style-type: none"> • Quantified by their length and width • Results from pavement shrinkage due to natural daily and seasonal temperature cycles, construction issues, or other factors

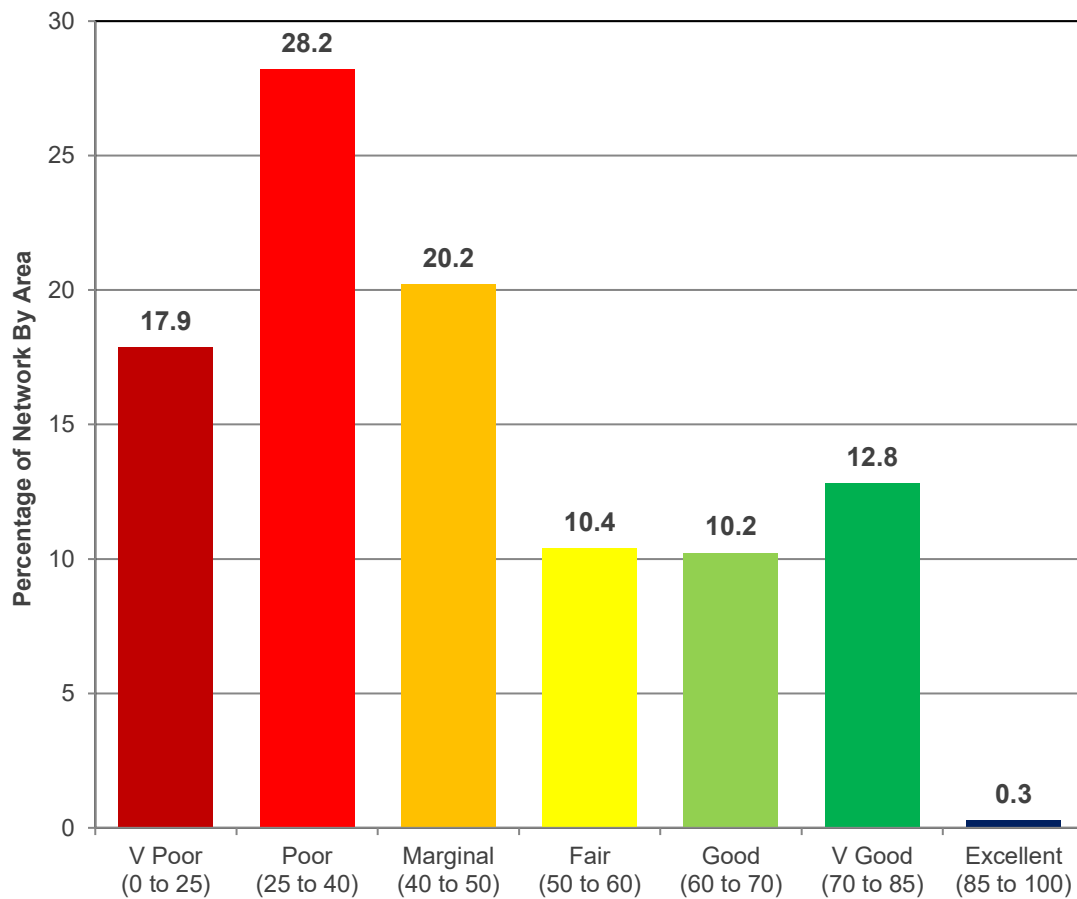
Figure 15 - Roadway Network Present Status Using Descriptive Terms

Figure 15 shows the distribution of pavement condition for the roadway network in Bear Valley.

- Ten percent (10%) of the streets are rated as Good and may still be candidates for slurry seals or thin overlays.
- Approximately thirty-one percent (31%) of the network can be considered in Fair to Marginal condition and represents candidates for progressively thicker overlay-based rehabilitation. If left untreated, they will decline rapidly into reconstruction candidates.

- Forty-six percent (46%) of the network is rated as Poor or Very Poor, meaning these roadways have deteriorated to the point where surface rehabilitation can no longer restore the pavement to a point of structural adequacy. Rehabilitation of the entire pavement structure is required for these segments.

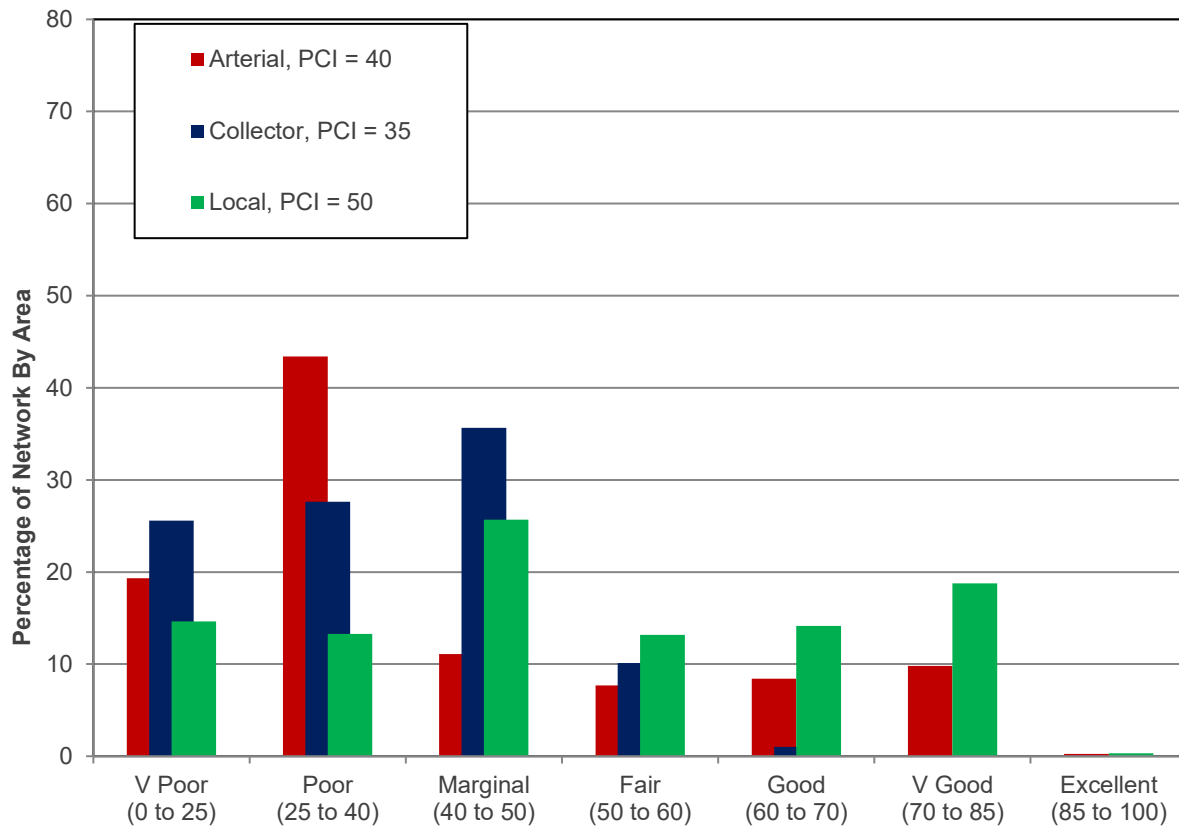
Figure 16 - Condition Rating by Functional Classification

Analyzing subsets of data in addition to the overall pavement condition can provide a better understanding of where an agency should focus its resources. **Figure 16** displays the distribution of pavement conditions for each functional class.

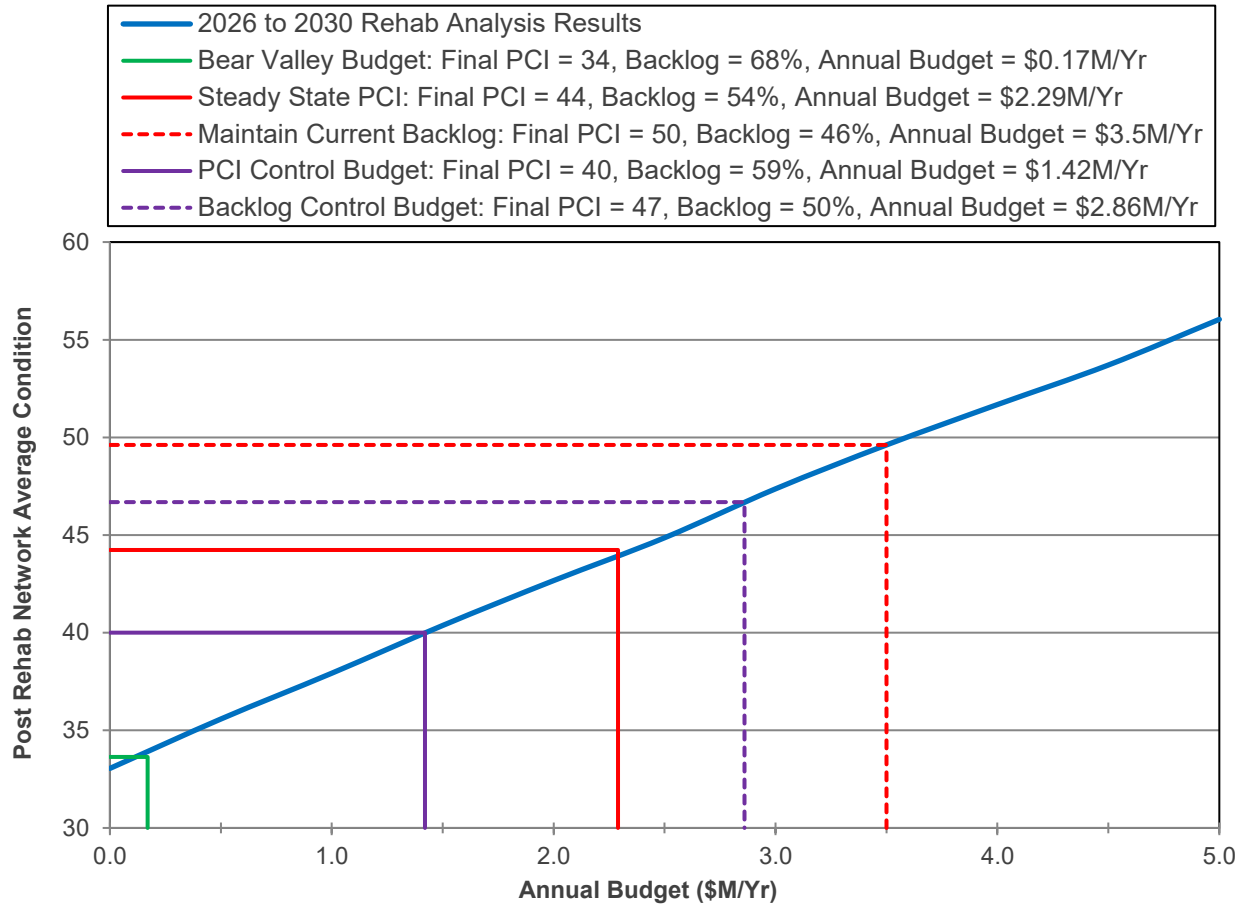
Figure 18 – Five-year Post Rehab Network PCI Analysis Results

The results of the analysis are summarized in **Figure 18**. The x-axis highlights the annual budget, while the y-axis plots the five-year Post Rehab Network Average PCI values. The diagonal blue line is the network trend model developed to show estimated PCI along with a funding range up to \$5M/Yr.

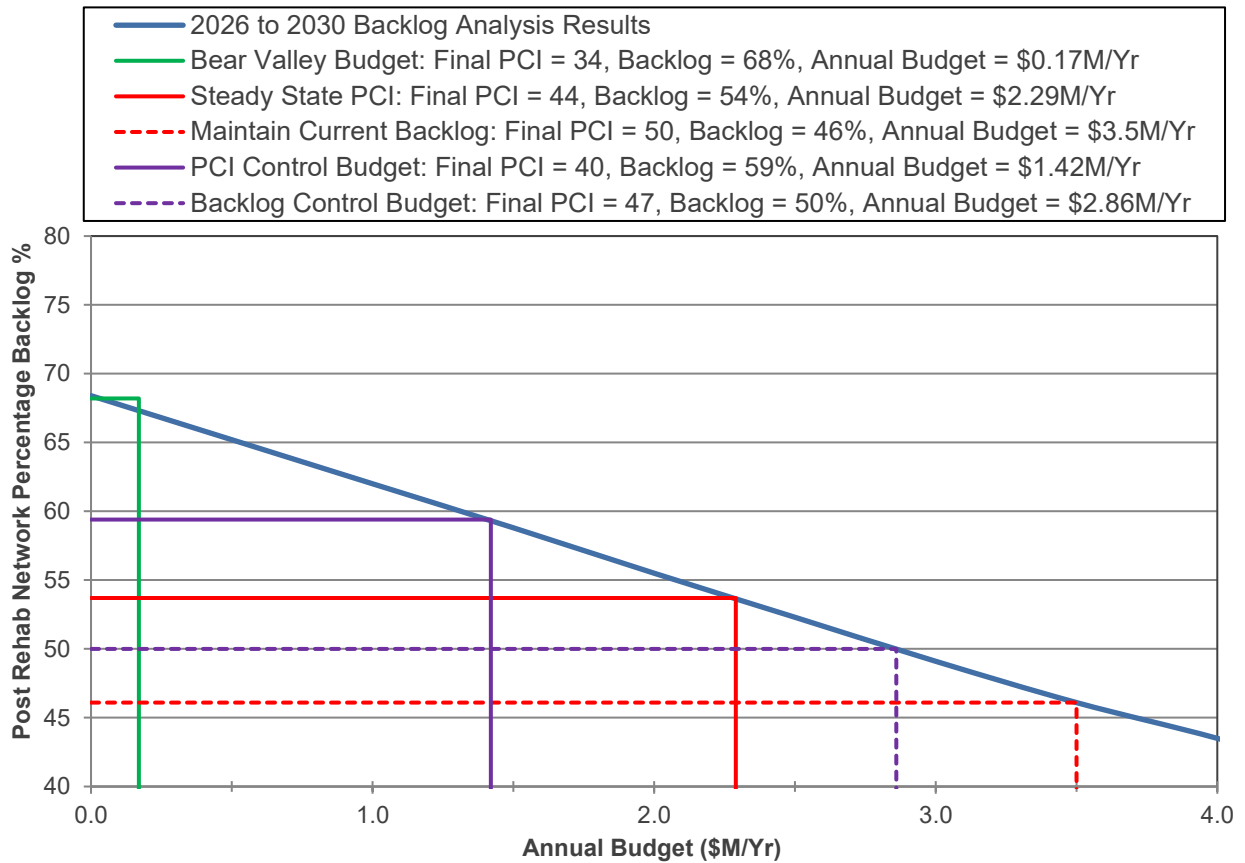
Figure 19 – Five-year Post Rehab Network Backlog Results

Figure 19 presents the resultant network backlog against the annual budget. It is similar to **Figure 18**, but instead of plotting the average PCI score, it displays the total backlog after five years with a blue diagonal line. The Community currently maintains a backlog of 46%. As the backlog grows, the funding required to return to the current level will increase.

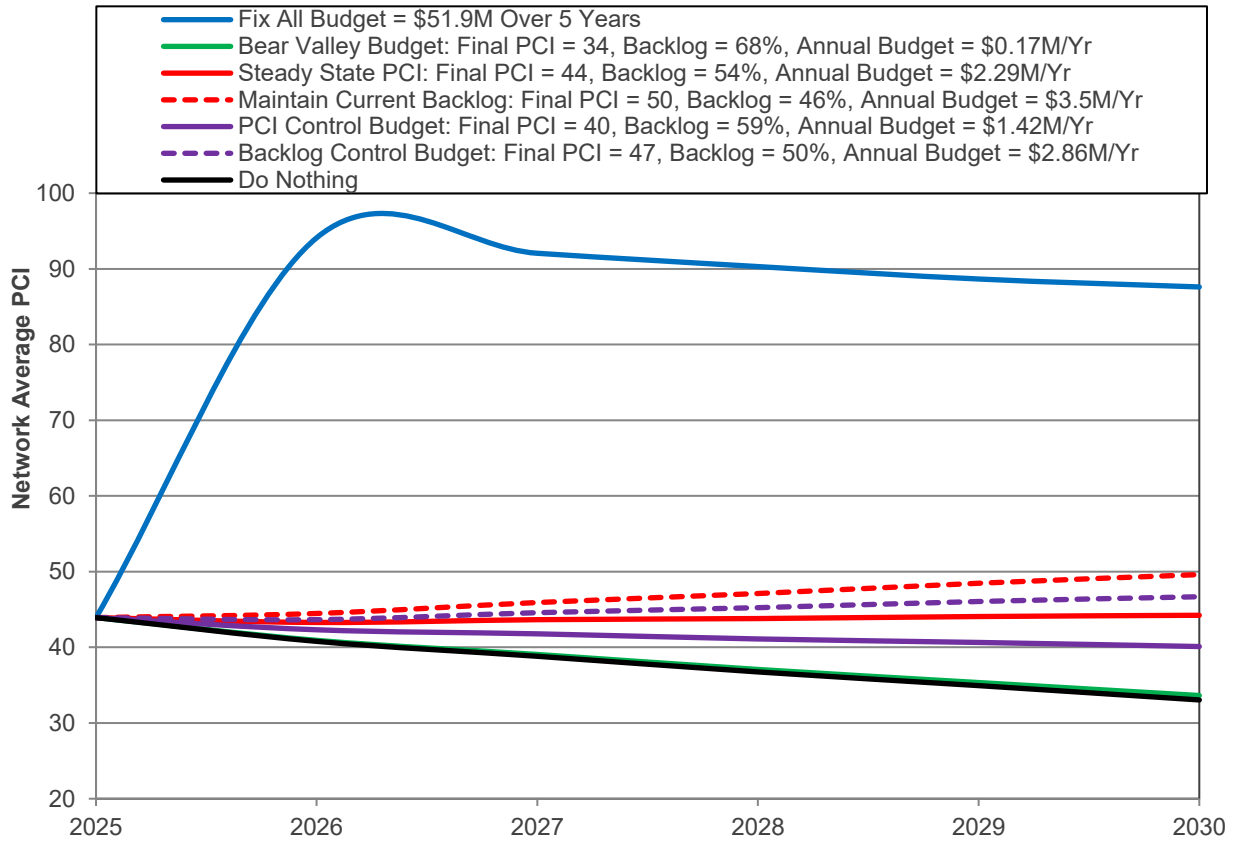
Figure 20 - Five-year Annual PCI

Figure 20 presents the analysis results on an annual basis. This shows that if the budget falls below \$2.29M/Yr. (Steady State PCI Budget), over time the overall condition of the roads is expected to deteriorate as the backlog grows.

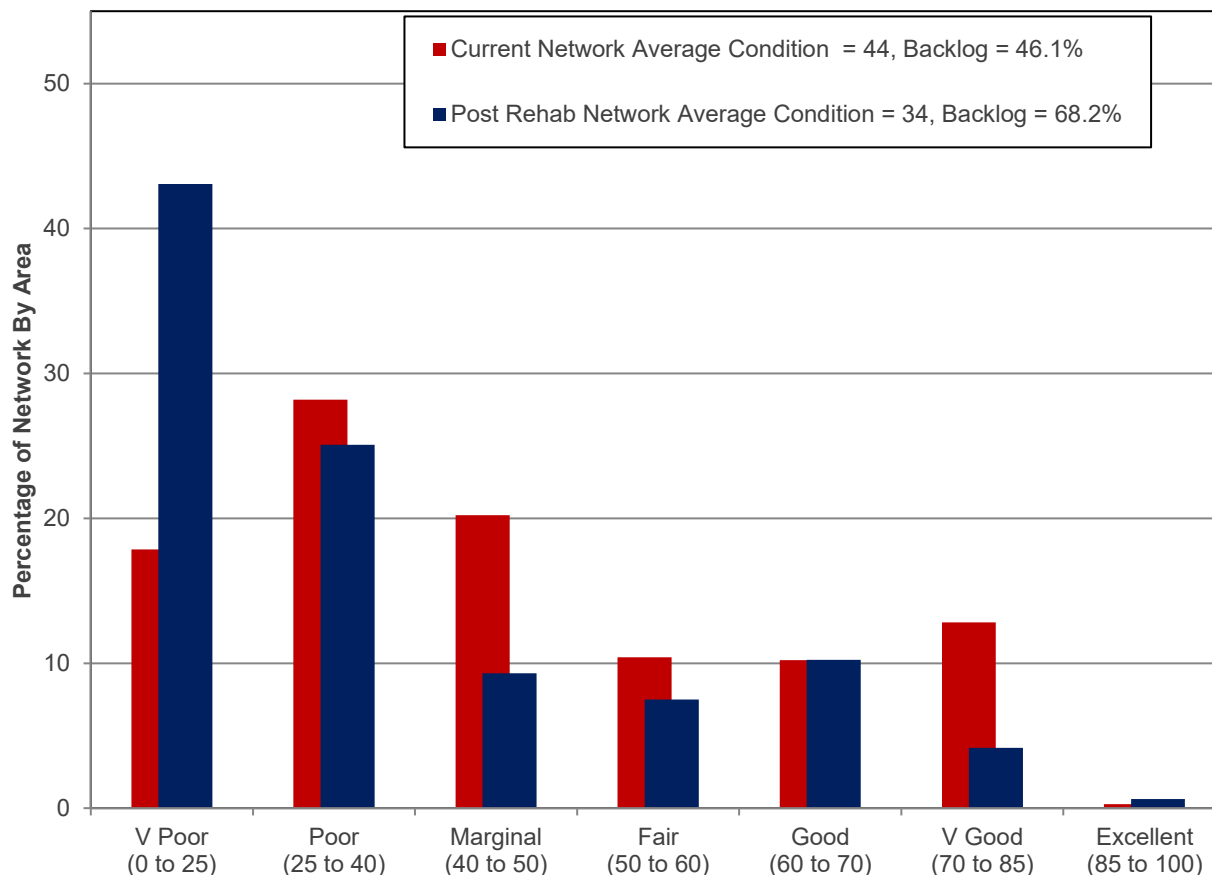
Figure 21 – Comparison of Pavement Condition (Current to 5-year Projection)

Figure 21 compares the percentage of the Community’s network area separated into each pavement condition category for two scenarios: the current network average condition (shown in red) and the projected condition in five years with the Community’s budget (shown in blue). The analysis shows that if the Community's current budget is maintained, the average PCI is expected to decrease to 34 by the end of the five-year analysis period, and the backlog is projected to increase to approximately 68%.

The pavement analysis models conducted using the ESA program showed that the current annual budget of \$0.17M for pavement management would result in negligible change in pavement condition over a period of five years, resulting in a five-year post rehab PCI of 34 and a backlog of 68%.
